**Flood Control Project Maintenance
Levee Inspections**
LMA District Cover Sheet
Spring 2019 Levee Inspection Results

Reclamation District No. 0524 Middle Roberts Island

Spring 2019 Levee Inspection Results

Waterway			Bank	Unit Miles
Unit No. 01 San Joaquin River			Left	6.20
	Spring (March - May)	Summer (June - August)	(September - November) Fall	Winter (December - February)
Unit Maintenance Rating (Fall Only)				
Date of Inspection	3/26/2019 - 3/27/2019			
DWR Inspector	Alberto De Leon			
Accompanied By	Zach Jojola DWR

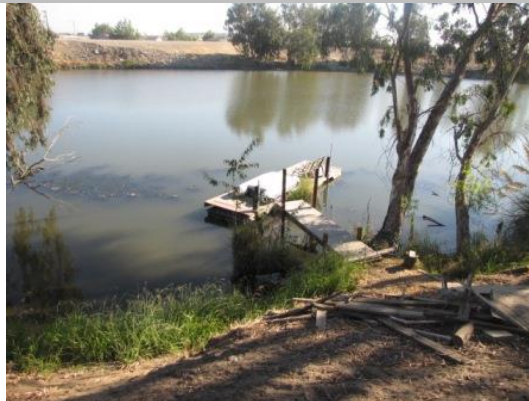
Photo 2 of 2 : SP_2019_RD0524_107_39_20190313_00055.jpg

Looking east at non-permitted boat dock.

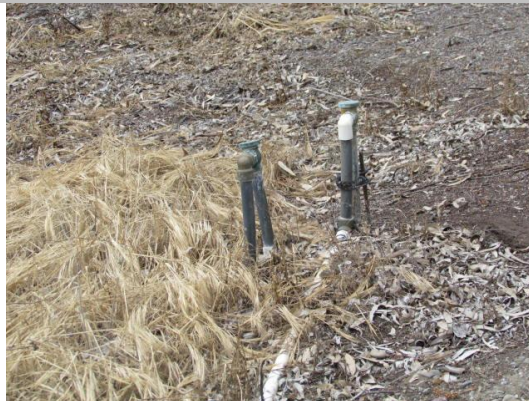
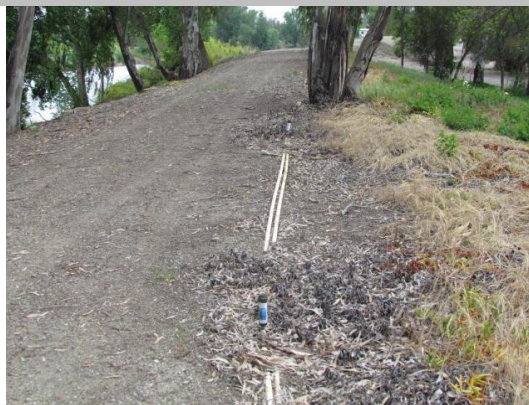
LM Start	1.65	Rating **	M	Issue No.	207
LM End	1.71	Issue Type +	En	Location *	LS
Category	Earthen Levee			GPS Latitude/Longitude	
				Start	End
Item	Encroachments			37.927237 °	37.926621 °
				-121.327183 °	-121.326400 °
DWR ID	DWR_RD0524_01_s_2016_207				
Comment Code					
LI : Landscape Irrigation					
Inspector Comment					
Sprinklers on landside shoulder

Looking south at sprinkler line and sprinklers on landward shoulder.

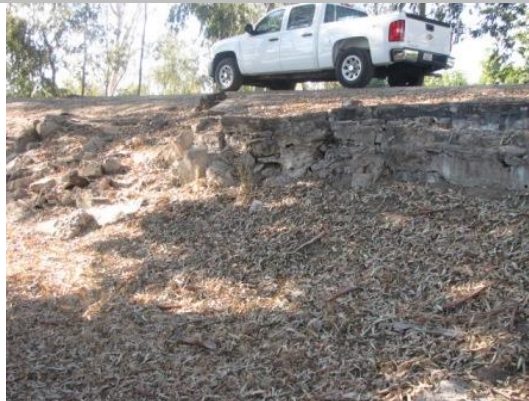
Photo 2 of 3 : SP_2019_RD0524_107_45_20190313_00063.jpg

Looking southwest at retaining wall connected to concrete stairs.

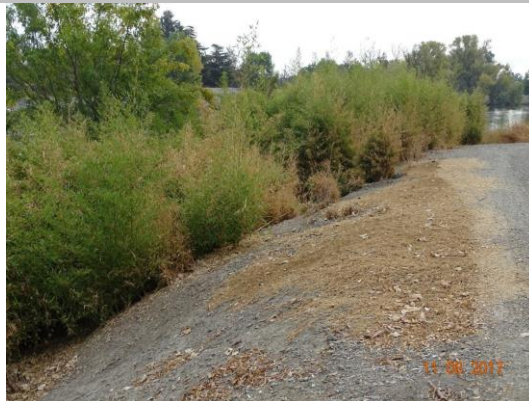
Photo 1 of 1 : SP_2019_RD0524_107_243_20190313_00263.jpg

LM Start	1.71	Rating **	U	Issue No.	243
LM End	1.72	Issue Type +	Ma	Location *	WS
Category	Earthen Levee			GPS Latitude/Longitude	
				Start	End
Item	Vegetation			37.926638 °	37.926471 °
				-121.326374 °	-121.326175 °
DWR ID	DWR_RD0524_01_f_2017_243				
Comment Code					
V2 : Remove the wild growth other than native grasses from the levee slopes.					
Inspector Comment

Looking southeast at the waterside slope.

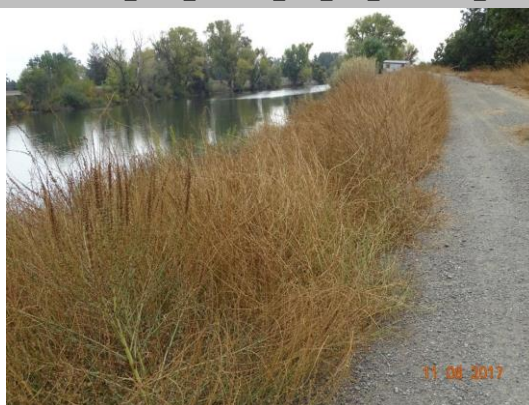
Photo 1 of 1 : SP_2019_RD0524_107_244_20190313_00264.jpg

LM Start	1.73	Rating **	M	Issue No.	244
LM End	1.75	Issue Type +	Ma	Location *	WS
Category	Earthen Levee			GPS Latitude/Longitude	
				Start	End
Item	Vegetation			37.926395 °	37.926191 °
				-121.326125 °	-121.325952 °
DWR ID	DWR_RD0524_01_f_2017_244				
Comment Code					
V2 : Remove the wild growth other than native grasses from the levee slopes.					
Inspector Comment

Looking southeast at the waterside slope.

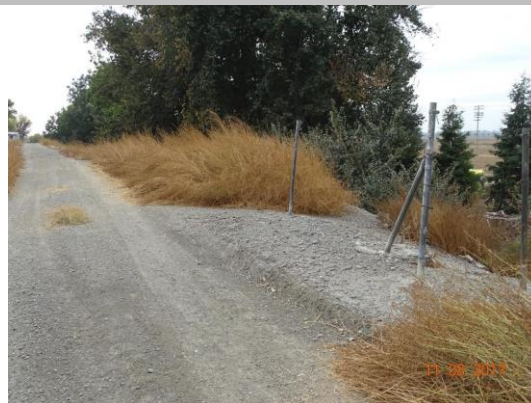
Photo 1 of 1 : SP_2019_RD0524_107_245_20190313_00265.jpg

LM Start	1.73	Rating **	U	Issue No.	245
LM End	1.75	Issue Type +	Ma	Location *	LS
Category	Earthen Levee			GPS Latitude/Longitude	
				Start	End
Item	Vegetation			37.926312 °	37.926093 °
				-121.326065 °	-121.325864 °
DWR ID	DWR_RD0524_01_f_2017_245				
Comment Code					
V2 : Remove the wild growth other than native grasses from the levee slopes.					
Inspector Comment

Looking southeast at the landside slope.

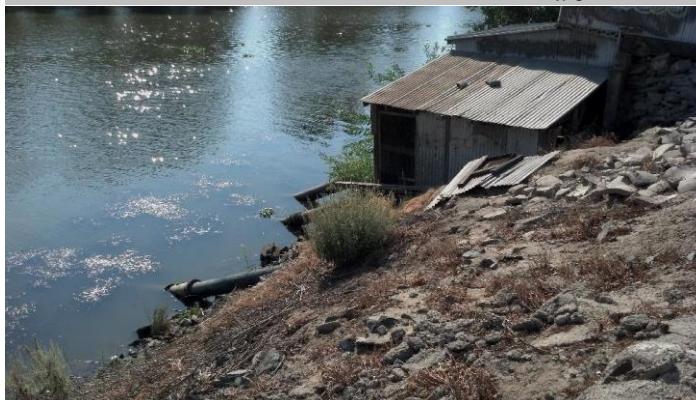
Photo 1 of 3 : UCIP_SP_2019_21866_37124.jpg

LM Start	1.80	Rating **	M	Issue No.	942	
LM End	1.80	Issue Type +	En	Location *		
Category	Supplemental			GPS Latitude/Longitude		
				Start	End	
Item	DWR UCIP Field Study			37.925480 °	37.925480 °	
				-121.325358 °	-121.325358 °	
DWR ID	24032					
Comment Code						
Inspector Comment						
FS_ID:21866 DS_ID:24032 EP_NO: N/A Repair Type: Non-Urgent Crossing Status: Found UCIP Comments: No permit identified for crossing. FIELD_STRUCT_DESC: 12-inch wrapped steel irrigation pipe through the levee, at an unknown depth. Pump, butterfly valves, vent, and siphon breaker at concrete pad 50 feet off the landside (LS) toe. Siphon breaker in 14-inch concrete standpipe on the LS shoulder. FS Date: 8/20/2013

Pipe visible at lower left.

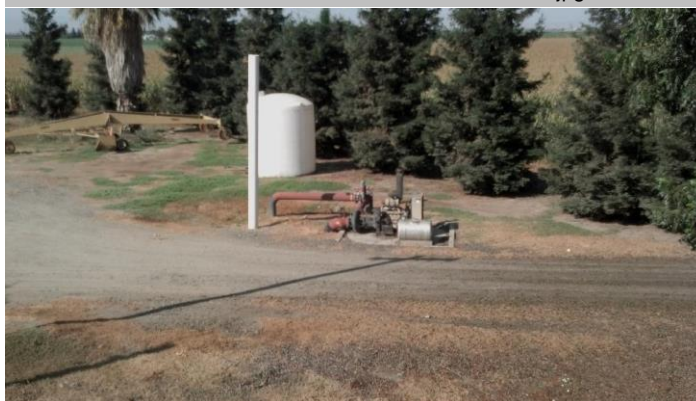
Photo 2 of 3 : UCIP_SP_2019_21866_37123.jpg

Pumping plant off LS toe.

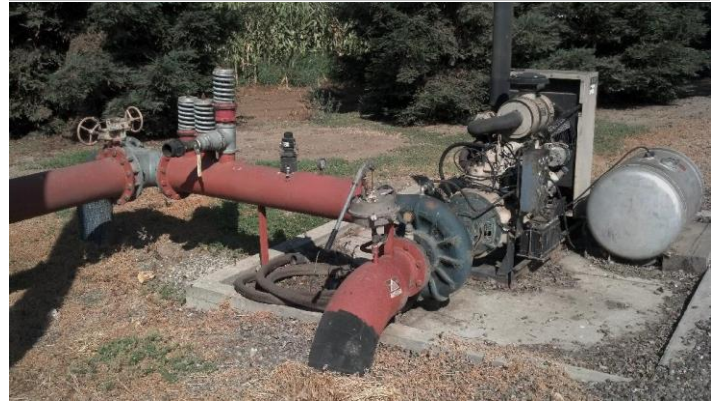
Photo 3 of 3 : UCIP_SP_2019_21866_37122.jpg

LM Start	1.80	Rating **	M	Issue No.	942 (cont)
LM End	1.80	Issue Type +	En	Location *	
Category	Supplemental			GPS Latitude/Longitude	
				Start	End
Item	DWR UCIP Field Study			37.925480 °	37.925480 °
				-121.325358 °	-121.325358 °
DWR ID	24032				
Comment Code					
Inspector Comment					
FS_ID:21866 DS_ID:24032 EP_NO: N/A Repair Type: Non-Urgent Crossing Status: Found UCIP Comments: No permit identified for crossing. FIELD_STRUCT_DESC: 12-inch wrapped steel irrigation pipe through the levee, at an unknown depth. Pump, butterfly valves, vent, and siphon breaker at concrete pad 50 feet off the landside (LS) toe. Siphon breaker in 14-inch concrete standpipe on the LS shoulder. FS Date: 8/20/2013

Pumping plant with siphon breaker, vents, and butterfly valves.

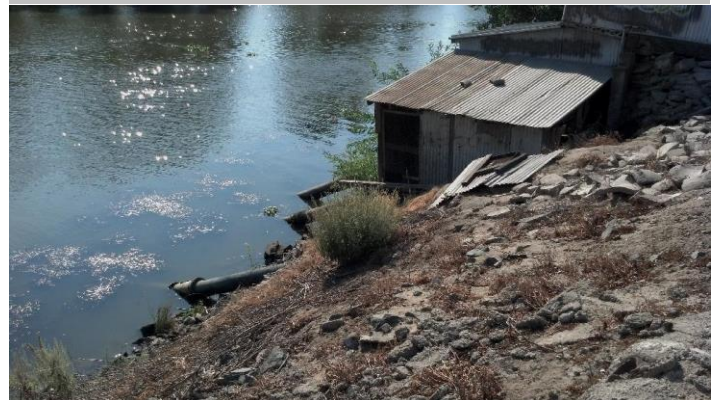
Photo 1 of 3 : UCIP_SP_2019_17847_29962.jpg

Comment Code						
Inspector Comment						
FS_ID:17847						
DS_ID:20609						
EP_NO: N/A						
Repair Type: Non-Urgent						
Crossing Status: Found						
UCIP Comments: Pipe appears abandoned and if so should be done so properly.						
FIELD_STRUCT_DESC: 14-inch irrigation pipe of an unknown material through the levee, 20 feet below the crown. 2 pumps and gate valves discharge into surge tank in pump house on the waterside (WS) slope. Concrete distribution box removed from the WS slope. Abandoned 36-inch diameter concrete standpipe on the landside (LS) toe next to service pole. [Additional Reference(s): DWR Levee Log, 2004. USACE San Joaquin O&M Manual 7, April 1964, (HLM 1.83)].						
FS Date: 8/20/2013

Pipes and pump house on WS slope.

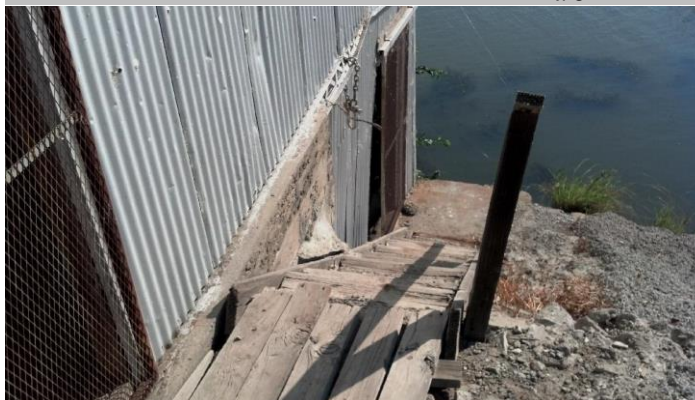
Photo 2 of 3 : UCIP_SP_2019_17847_29961.jpg

Steps to pump on WS slope.

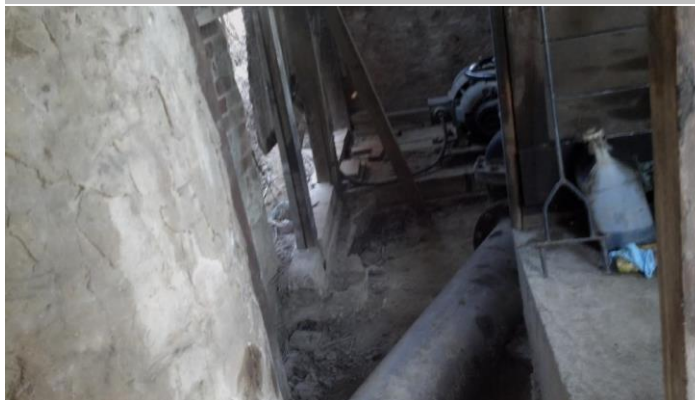
Photo 3 of 3 : UCIP_SP_2019_17847_29960.jpg

Pipes at connection to concrete surge box on WS inside pumphouse.

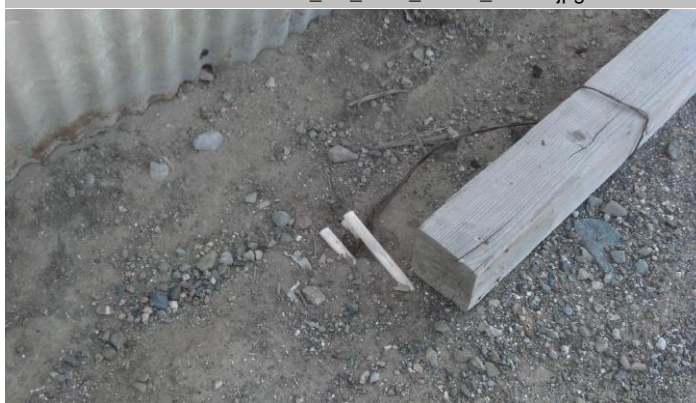
Photo 1 of 2 : UCIP_SP_2019_21865_37121.jpg

LM Start	1.81	Rating **	M	Issue No.	944
LM End	1.81	Issue Type +	En	Location *	
Category	Supplemental			GPS Latitude/Longitude	
				Start	End
Item	DWR UCIP Field Study			37.925431 °	37.925431 °
				-121.325310 °	-121.325310 °
DWR ID	24033				
Comment Code					
Inspector Comment					
FS_ID:21865 DS_ID:24033 EP_NO: N/A Repair Type: Non-Urgent Crossing Status: Found UCIP Comments: Pipes appear abandoned and should be removed from levee. FIELD_STRUCT_DESC: *ABANDONED* One 1-inch and two 0.75-inch polyvinyl chloride conduits of an unknown purpose through the levee, 6 inches below the crown. FS Date: 8/20/2013

Pipes visible on WS shoulder directly in front of pumphouse.

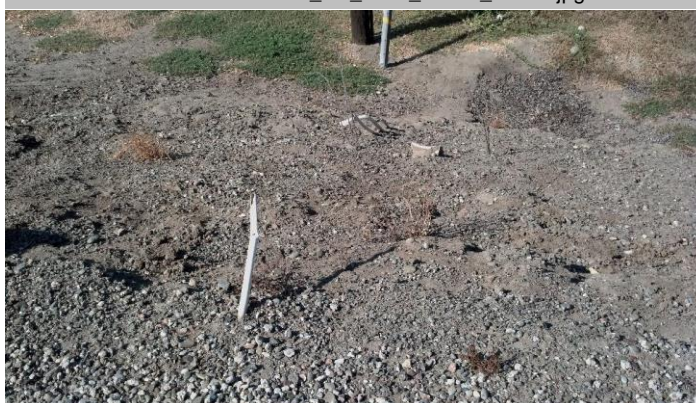
Photo 2 of 2 : UCIP_SP_2019_21865_37120.jpg

Pipes visible on LS slope.

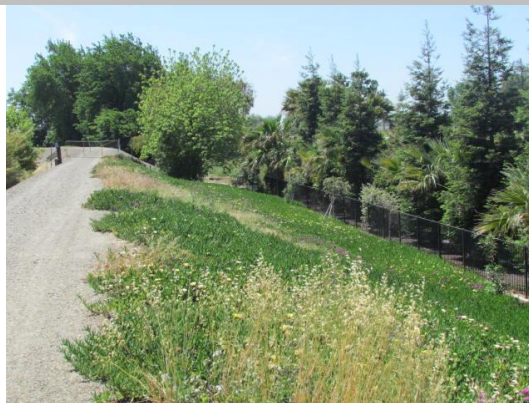
Photo 1 of 1 : SP_2019_RD0524_107_78_20190313_00107.jpg

LM Start	1.90	Rating **	U	Issue No.	78
LM End	1.94	Issue Type +	En	Location *	LS
Category	Earthen Levee			GPS Latitude/Longitude	
				Start	End
Item	Vegetation			37.924364 °	37.923805 °
				-121.324473 °	-121.324238 °
DWR ID	DWR_RD0524_01_s_2012_78				
Comment Code					
V6 : Landscaping					
Inspector Comment

Looking southwest at landscaping on landside slope. (Spring 2012)

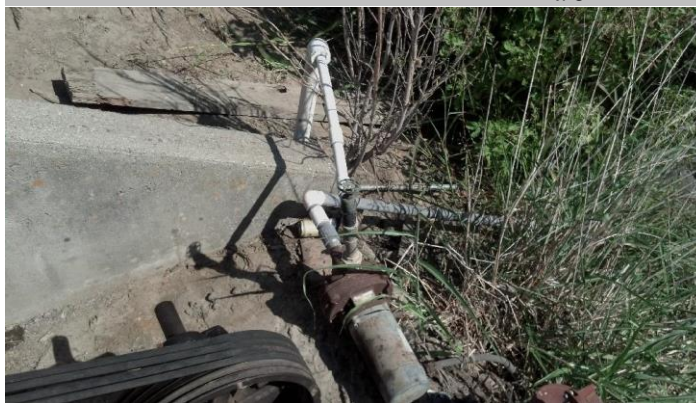
Photo 1 of 3 : UCIP_SP_2019_21872_37128.jpg

LM Start	1.99	Rating **	M	Issue No.	945
LM End	1.99	Issue Type +	En	Location *	
Category	Supplemental			GPS Latitude/Longitude	
				Start	End
Item	DWR UCIP Field Study			37.923022 °	37.923022 °
				-121.323953 °	-121.323953 °
DWR ID	24035				
Comment Code					
Inspector Comment					
FS_ID:21872 DS_ID:24035 EP_NO: N/A Repair Type: Non-Urgent Crossing Status: Found UCIP Comments: No permit identified for this crossing. FIELD_STRUCT_DESC: 3-inch polyvinyl chloride domestic non-potable water line through the levee, at an unknown depth. Pump on concrete pad at the waterside (WS) toe. FS Date: 8/20/2013

Pump on concrete pad at WS slope.

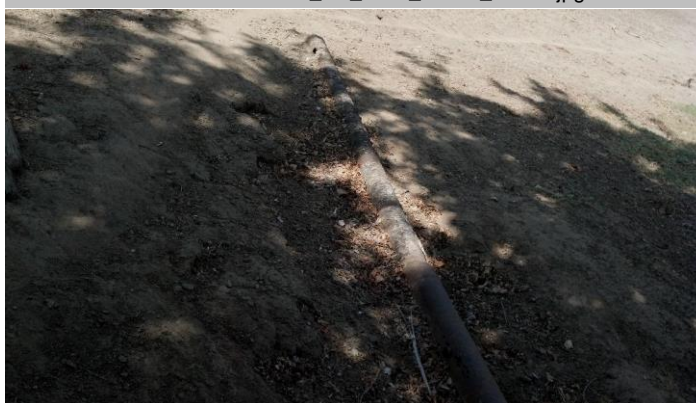
Photo 1 of 2 : UCIP_SP_2019_21883_37134.jpg

LM Start	2.03	Rating **	M	Issue No.	946	
LM End	2.03	Issue Type +	En	Location *		
Category	Supplemental			GPS Latitude/Longitude		
				Start	End	
Item	DWR UCIP Field Study			37.922535 °	37.922535 °	
				-121.323568 °	-121.323568 °	
DWR ID	24036					
Comment Code						
Inspector Comment						
FS_ID:21883						
DS_ID:24036						
EP_NO: N/A						
Repair Type: Non-Urgent						
Crossing Status: Found						
UCIP Comments: Pipe abandoned and should be done so properly.						
Holes visible throughout exposed pipe.						
FIELD_STRUCT_DESC: 5-inch wrapped steel irrigation pipe through the levee, 6 feet below the crown. No pump or other appurtenances found.						
FS Date: 8/20/2013

Pipe visible on WS slope.

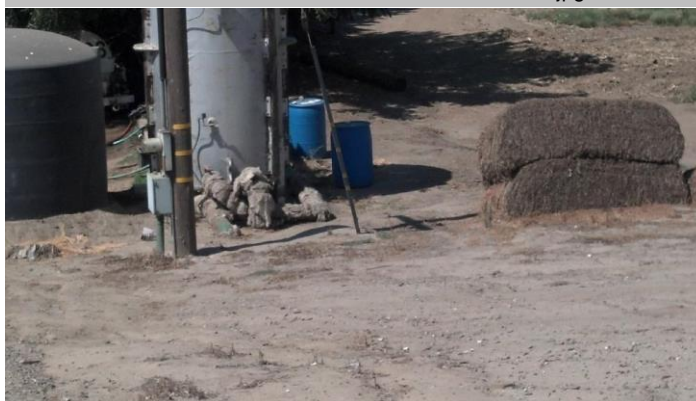
Photo 1 of 3 : UCIP_SP_2019_21895_37142.jpg

LM Start	2.07	Rating **	M	Issue No.	947
LM End	2.07	Issue Type +	En	Location *	
Category	Supplemental			GPS Latitude/Longitude	
				Start	End
Item	DWR UCIP Field Study			37.922080 °	37.922080 °
				-121.323118 °	-121.323118 °
DWR ID	24038				
Comment Code					
Inspector Comment					
FS_ID:21895 DS_ID:24038 EP_NO: N/A Repair Type: Non-Urgent Crossing Status: Found UCIP Comments: No permit identified for this crossing. FIELD_STRUCT_DESC: 6-inch steel irrigation pipe through the levee, at an unknown depth. Vent, meter, butterfly valve, and pump at pump house on the waterside (WS) slope. FS Date: 8/20/2013

Steel irrigation line visible in front of tank to right of powerpole off LS toe.

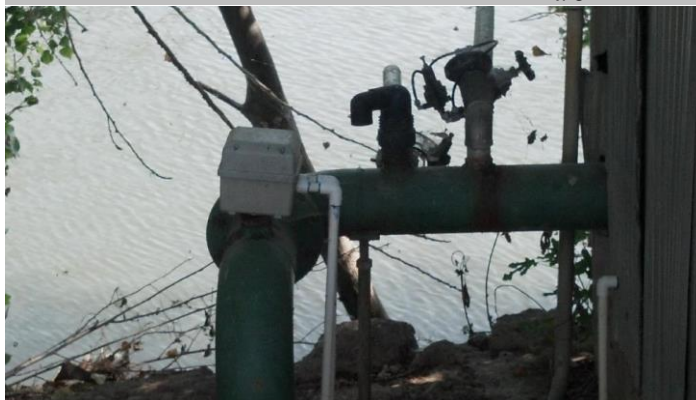
Photo 2 of 3 : UCIP_SP_2019_21895_37141.jpg

Irrigation line visible on side of pumphouse.

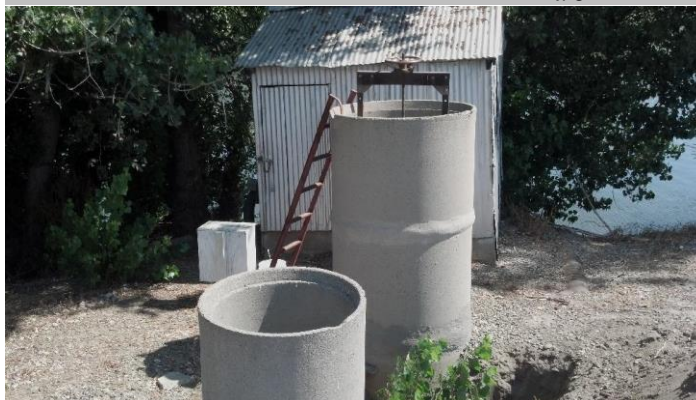
Photo 1 of 3 : UCIP_SP_2019_17944_30045.jpg

Comment Code						
Inspector Comment						
FS_ID:17944						
DS_ID:20612						
EP_NO: N/A						
Repair Type: Non-Urgent						
Crossing Status: Found						
UCIP Comments: Soil excavated from cover over pipe on WS next to concrete riser. May indicate a leak or other problem.						
FIELD_STRUCT_DESC: 20-inch steel irrigation pipe through the levee, 15 feet below the crown. Pump in pump house on the waterside (WS) slope. Slide gate in 4-foot diameter concrete standpipe on the WS slope with secondary concrete standpipe. Polyvinyl chloride standpipe visible 350 feet off the landside (LS) toe. [Additional Reference(s): DWR Levee Log, 2004. USACE San Joaquin O&M Manual 7, April 1964, (HLM 2.10)].						
FS Date: 8/20/2013

Slide gate in concrete riser with secondary concrete riser in foreground. Pump house in background.

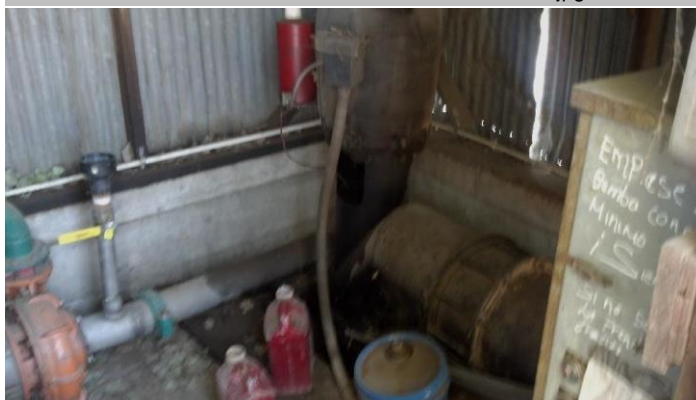
Photo 2 of 3 : UCIP_SP_2019_17944_30044.jpg

Pump and pipe inside pumphouse.

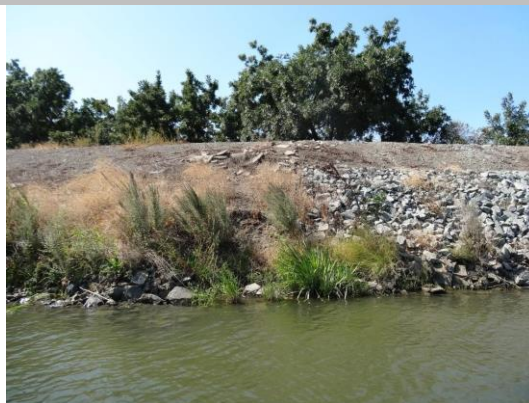
Photo 2 of 3 : SP_2019_RD0524_107_70_20190313_00096.jpg

Close view of the erosion.

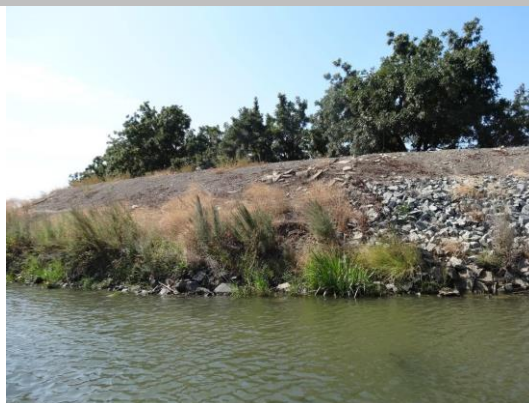
Photo 3 of 3 : SP_2019_RD0524_107_70_20190313_00097.jpg

Front view of the erosion.

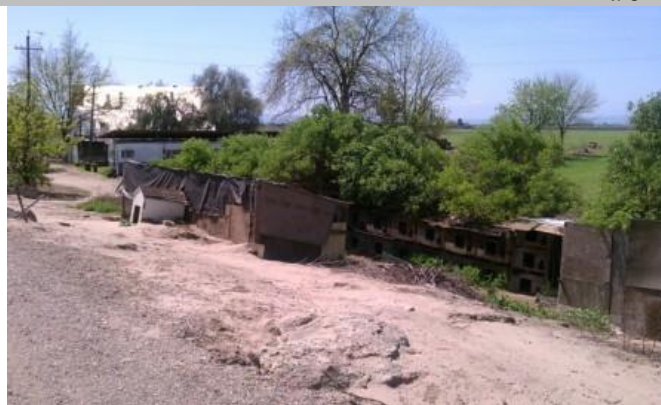
Photo 2 of 2 : SP_2019_RD0524_107_42_20190313_00057.jpg

Looking at animal pens on landside slope and toe.

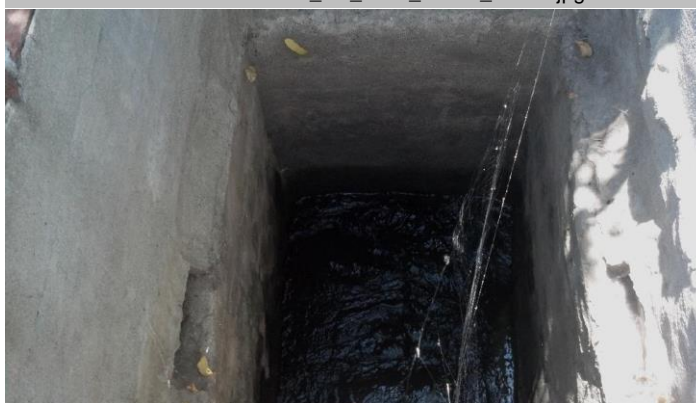
Photo 3 of 3 : UCIP_SP_2019_21935_37160.jpg

Distribution box on LS toe.

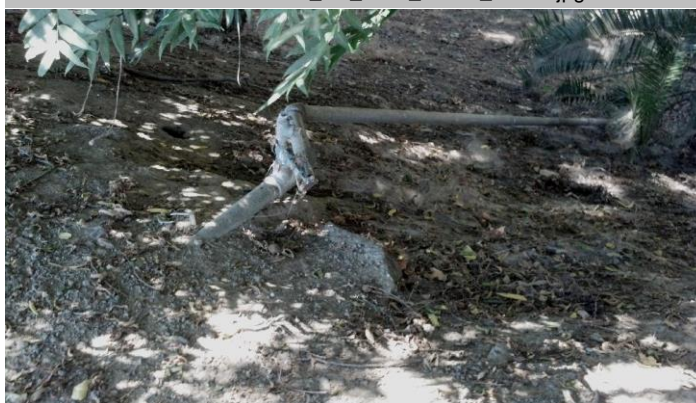
Photo 1 of 2 : UCIP_SP_2019_18085_30191.jpg

LM Start	2.73	Rating **	M	Issue No.	950
LM End	2.73	Issue Type +	En	Location *	
Category	Supplemental			GPS Latitude/Longitude	
				Start	End
Item	DWR UCIP Field Study			37.915698 °	37.915698 °
				-121.322501 °	-121.322501 °
DWR ID	20616				
Comment Code					
Inspector Comment					
FS_ID:18085 DS_ID:20616 EP_NO: N/A Repair Type: Non-Urgent Crossing Status: Found UCIP Comments: No permit identified for crossing. Unkonw use. Pipe should be removed. FIELD_STRUCT_DESC: 3-inch galvanized iron pipe of an unknown purpose through the levee, 0.3 feet below the crown. Valve on the landside (LS) shoulder. [Additional Reference(s): DWR Levee Log, 2004]. FS Date: 8/20/2013 3:28:19 PM

Pipe and vent visible on LS slope.

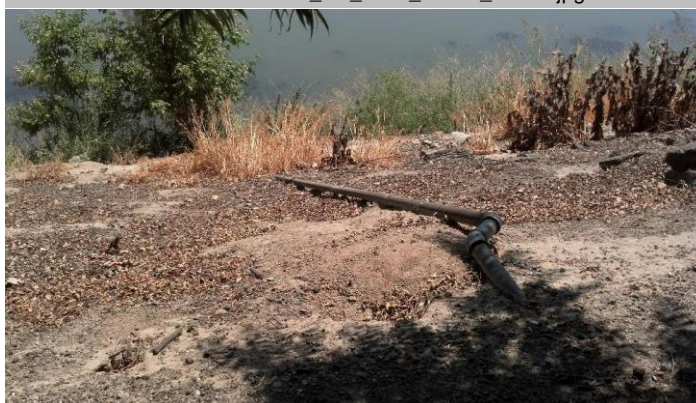
Photo 2 of 2 : UCIP_SP_2019_18085_30190.jpg

LM Start	2.73	Rating **	M	Issue No.	950 (cont)	
LM End	2.73	Issue Type +	En	Location *		
Category	Supplemental			GPS Latitude/Longitude		
				Start	End	
Item	DWR UCIP Field Study			37.915698 °	37.915698 °	
				-121.322501 °	-121.322501 °	
DWR ID	20616					
Comment Code						
Inspector Comment						
FS_ID:18085						
DS_ID:20616						
EP_NO: N/A						
Repair Type: Non-Urgent						
Crossing Status: Found						
UCIP Comments: No permit identified for crossing. Unknoww use.						
Pipe should be removed.						
FIELD_STRUCT_DESC: 3-inch galvanized iron pipe of an unknown						
purpose through the levee, 0.3 feet below the crown. Valve on the						
lanside (LS) shoulder. [Additional Reference(s): DWR Levee Log,						
2004].						
FS Date: 8/20/2013 3:28:19 PM

Pipe visible on WS slope.

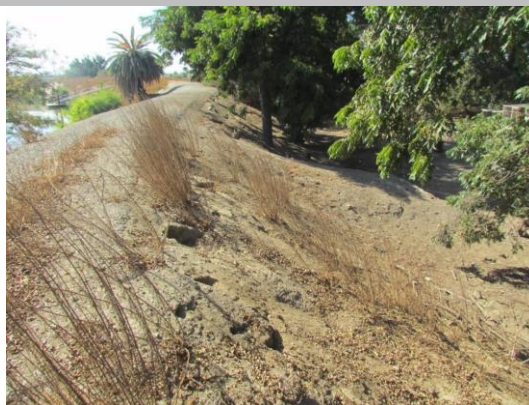
LM Start	2.77	Rating **	U	Issue No.	219
LM End	2.80	Issue Type +	Ma	Location *	LS
Category	Earthen Levee			GPS Latitude/Longitude	
				Start	End
Item	Animal Control			37.915195 °	37.915052 °
				-121.322930 °	-121.323430 °
DWR ID	DWR_RD0524_01_f_2016_219				
Comment Code					
A1 : Exterminate rodents and backfill and compact or grout burrows.					
Inspector Comment					
Several large rodent holes on landside slope.

Looking at typical rodent hole on waterward slope.

Looking south at several rodent holes on landward slope.

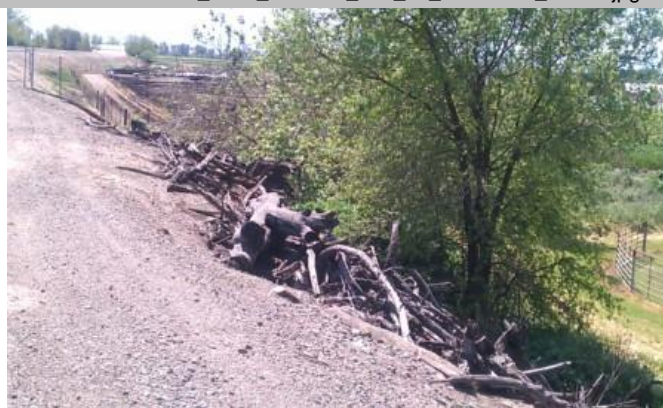
Photo 1 of 1 : SP_2019_RD0524_107_50_20190313_00070.jpg

LM Start	2.92	Rating **	M	Issue No.	50
LM End	2.92	Issue Type +	En	Location *	LS
Category	Earthen Levee			GPS Latitude/Longitude	
				Start	End
Item	Encroachments			37.913528 °	37.913528 °
				-121.324434 °	-121.324434 °
DWR ID	DWR_RD0524_01_s_2012_50				
Comment Code					
TR : Tree or limb					
Inspector Comment

Looking southwest at prunings on landside slope.

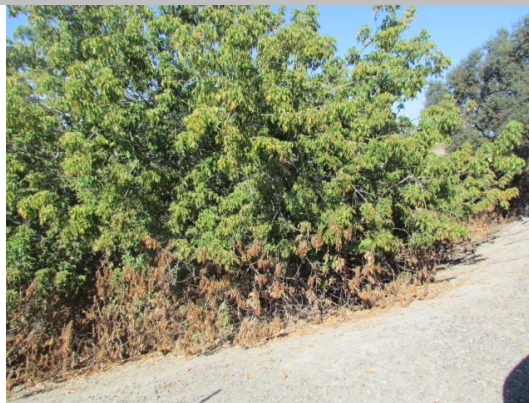
Photo 1 of 2 : SP_2019_RD0524_107_51_20190313_00071.jpg

LM Start	2.93	Rating **	U	Issue No.	51
LM End	2.93	Issue Type +	Ma	Location *	LS
Category	Earthen Levee			GPS Latitude/Longitude	
				Start	End
Item	Trim / Thin Trees			37.913415 °	37.913389 °
				-121.324503 °	-121.324440 °
DWR ID	DWR_RD0524_01_s_2012_51				
Comment Code					
T1 : Trim trees to at least five feet above ground level.					
Inspector Comment					
Untrimmed trees on landside slope and toe.

Looking south at dense trees on landward slope fall 2015

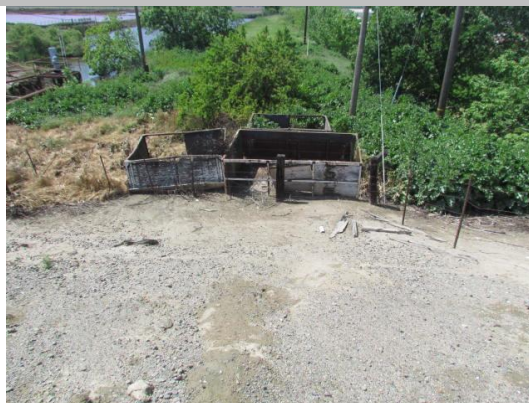
Photo 1 of 1 : SP_2019_RD0524_107_210_20190313_00215.jpg

LM Start	2.94	Rating **	M	Issue No.	210
LM End	2.94	Issue Type +	En	Location *	LS
Category	Earthen Levee			GPS Latitude/Longitude	
				Start	End
Item	Encroachments			37.913198 °	37.913198 °
				-121.324490 °	-121.324490 °
DWR ID	DWR_RD0524_01_s_2016_210				
Comment Code					
GA : Garbage					
Inspector Comment					
Old containers at landside toe.

Looking west at abandoned containers at landward toe.

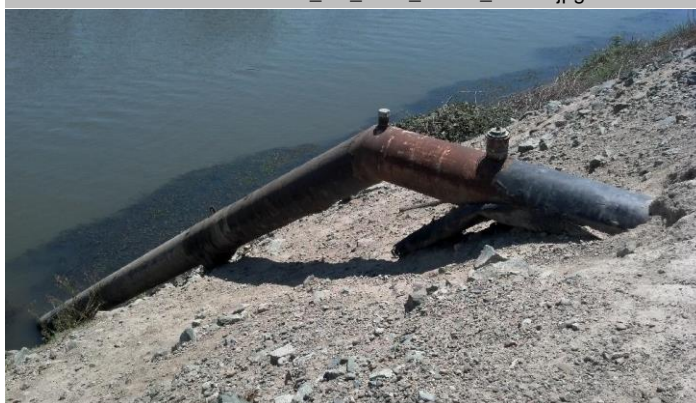
Photo 1 of 2 : UCIP_SP_2019_18089_30198.jpg

Comment Code					
Inspector Comment					
FS_ID:18089					
DS_ID:20617					
EP_NO: N/A					
Repair Type: Non-Urgent					
Crossing Status: Indicator Found					
UCIP Comments: Review crossing with inspector as records indicate that this should be an 8-inch pipe through levee 3.0 feet below crown, pump on landward side. Siphon breaker on the waterward slope. Originally included in the 1964 O&M manual.					
FIELD_STRUCT_DESC: 16-inch wrapped steel storm discharge pipe through the levee, 1.5 feet below the crown. Pump on steel pile structure at drainage canal off landside (LS) toe. [Additional Reference(s): USACE San Joaquin O&M Manual 7, April 1964, (HLM 2.99) 9-inch pipe listed].					
FS Date: 8/20/2013

PVC wrapped pipe and siphon breaker visible on WS slope.

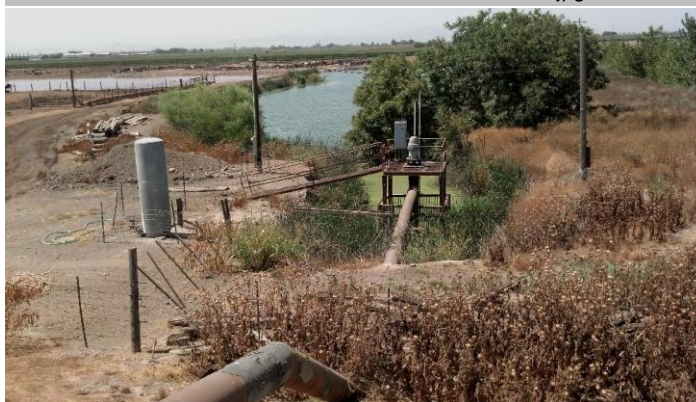
Photo 2 of 2 : UCIP_SP_2019_18089_30197.jpg

Pipe, pump, power pole, and meter visible off LS toe.

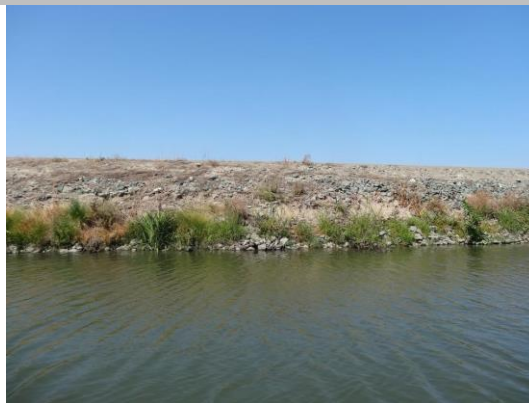
Photo 1 of 4 : SP_2019_RD0524_107_71_20190313_00098.jpg

LM Start	2.96	Rating **	U	Issue No.	71
LM End	2.96	Issue Type +	Ma	Location *	WS
Category	Supplemental			GPS Latitude/Longitude	
				Start	End
Item	DWR Erosion Survey			37.913010 °	37.913010 °
				-121.324490 °	-121.324490 °
DWR ID	RD0524U01RM43.52				
Comment Code					
Inspector Comment					
09/13/2017: A new pocket erosion observed at the eroison site, next to an irrigation pipe.					
07/25/2016: No significant change observed.					
06/24/2015: No significant change observed.					
06/19/2014: No significant change observed.					
08/13/2013: No significant change observed.					
08/07/2012: The site was first reported in 2012 spring levee inspection report. [2017 Site ID:RD0524U01RM43.52]

Front view of the erosion.

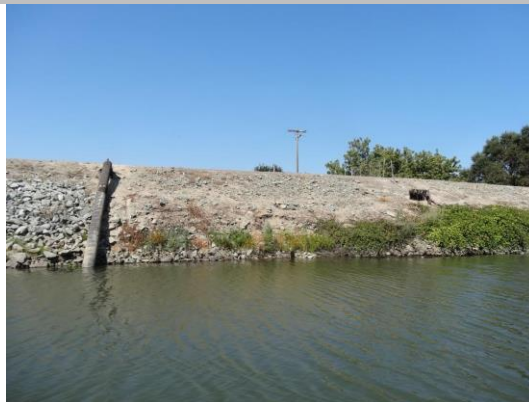
Photo 2 of 4 : SP_2019_RD0524_107_71_20190313_00099.jpg

View of the newly developed pocket erosion next to an irrigation pipe.

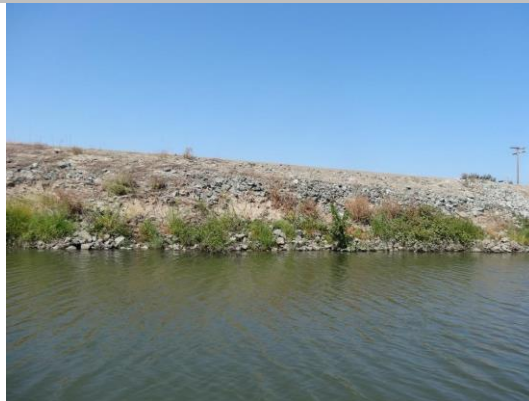
Photo 3 of 4 : SP_2019_RD0524_107_71_20190313_00100.jpg

Close view of the erosion.

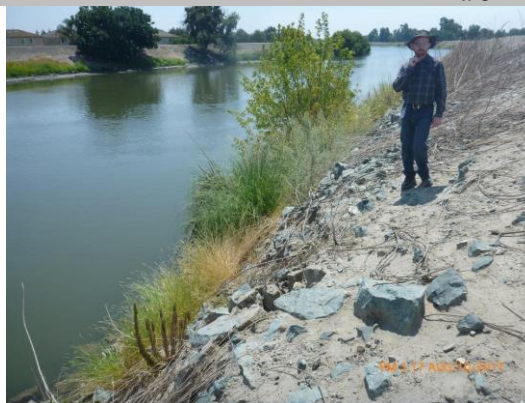
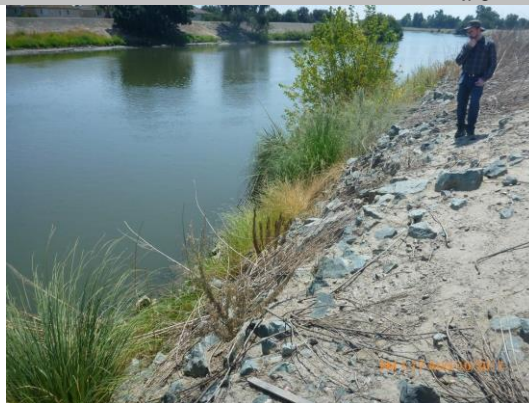
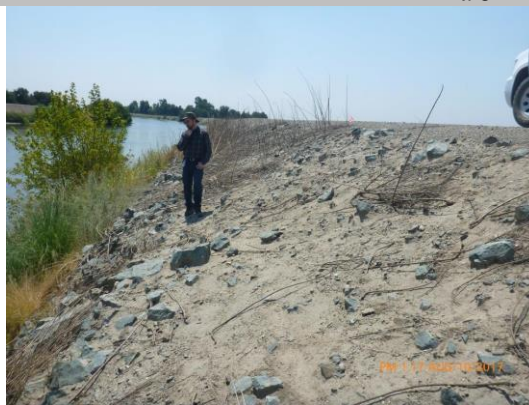
LM Start	2.99	Rating **	A/W	Issue No.	228
LM End	3.01	Issue Type +	Ma	Location *	
Category	Supplemental			GPS Latitude/Longitude	
				Start	End
Item	2017 Storm Damage			37.912500 °	37.912300 °
				-121.324700 °	-121.324700 °
DWR ID	DWR_RD0524_01_f_2017_228				
Comment Code					
Inspector Comment					
Levee Evaluation Comments					
Description:Slope protection repairs are needed along the waterside slope due to erosion and riprap displacement from high water. Based upon levee inspections, it was determined the waterside levee slope is eroding, deteriorating, and degrading. The eroded levee sections need to be restored back to design standards to prevent further deterioration and damage.					
Site ID No:529					
Site Designation:LMA-435					
Repair Type: Erosion					
Rating:Area of Concern					
Field Date:8/10/2017					
Notes:

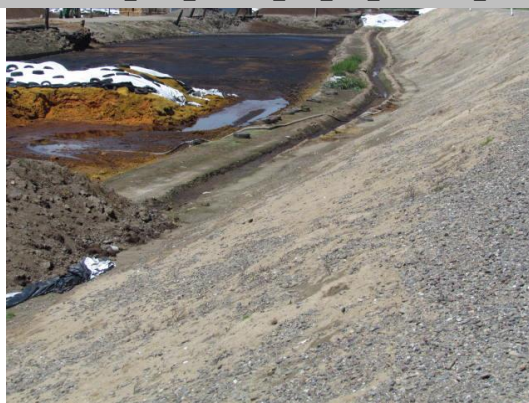
Photo 1 of 2 : SP_2019_RD0524_107_212_20190313_00217.jpg

LM Start	3.11	Rating **	M	Issue No.	212
LM End	3.27	Issue Type +	En	Location *	LS
Category	Earthen Levee			GPS Latitude/Longitude	
				Start	End
Item	Encroachments			37.910876 °	37.908558 °
				-121.325181 °	-121.325394 °
DWR ID	DWR_RD0524_01_s_2016_212				
Comment Code					
DT : Ditch					
Inspector Comment					
Shallow drainage ditch at landside toe.

Looking northwest at southend of ditch at landward toe.

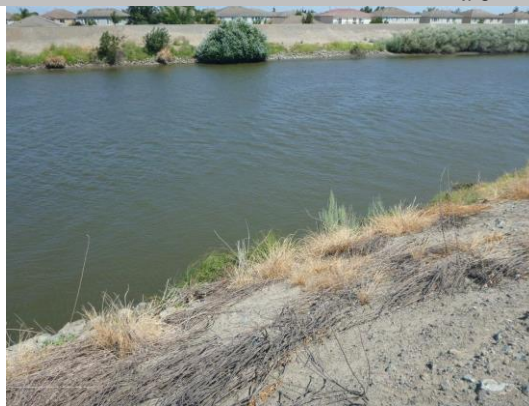
Photo 1 of 2 : LEVAL_SP_2019_466_2228.jpg

LM Start	3.23	Rating **	A/W	Issue No.	229
LM End		Issue Type +	Ma	Location *	
Category	Supplemental			GPS Latitude/Longitude	
				Start	End
Item	2017 Storm Damage			37.909200 °	°
				-121.325300 °	°
DWR ID	DWR_RD0524_01_f_2017_229

Comment Code					
Inspector Comment					
Levee Evaluation Comments					
Description:Slope protection repairs are needed along the waterside slope due to erosion. Based upon levee inspections, it was determined the waterside levee slopes were eroding, deteriorating and degrading in concave pocket sections at various locations along this levee reach. The eroded levee sections need to be restored back to design standards to prevent further deterioration of the damaged levee sections.					
Site ID No:466					
Site Designation:LMA-293					
Repair Type: Erosion					
Rating:Area of Concern					
Field Date:7/26/2017					
Notes: Lower priority because damage is only on the lower 1/5 of slope. The slopes US and DS are rocked. Levee is narrow here.

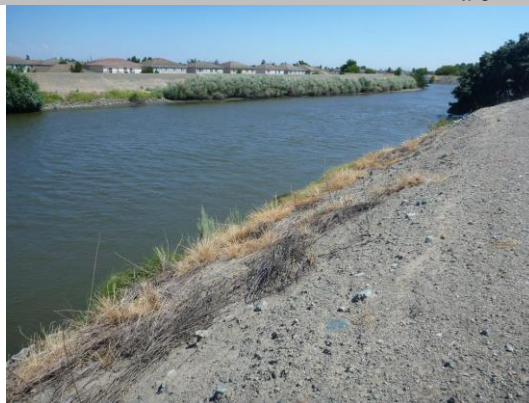
Photo 2 of 2 : LEVAL_SP_2019_466_2229.jpg

LM Start	3.23	Rating **	A/W	Issue No.	229 (cont)
LM End		Issue Type +	Ma	Location *	
Category	Supplemental			GPS Latitude/Longitude	
				Start	End
Item	2017 Storm Damage			37.909200 °	°
				-121.325300 °	°
DWR ID	DWR_RD0524_01_f_2017_229

Comment Code					
Inspector Comment					
<p>Levee Evaluation Comments</p> <p>Description: Slope protection repairs are needed along the waterside slope due to erosion. Based upon levee inspections, it was determined the waterside levee slopes were eroding, deteriorating and degrading in concave pocket sections at various locations along this levee reach. The eroded levee sections need to be restored back to design standards to prevent further deterioration of the damaged levee sections.</p> <p>Site ID No: 466</p> <p>Site Designation: LMA-293</p> <p>Repair Type: Erosion</p> <p>Rating: Area of Concern</p> <p>Field Date: 7/26/2017</p> <p>Notes: Lower priority because damage is only on the lower 1/5 of slope. The slopes US and DS are rocky. Levee is narrow here.</p>

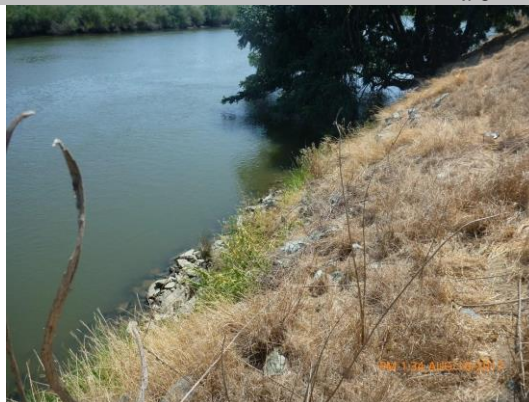
Photo 1 of 3 : LEVAL_SP_2019_528_4193.jpg

LM Start	3.26	Rating **	A/W	Issue No.	230
LM End	3.26	Issue Type +	Ma	Location *	
Category	Supplemental			GPS Latitude/Longitude	
				Start	End
Item	2017 Storm Damage			37.908800 °	37.908700 °
				-121.325400 °	-121.325300 °
DWR ID	DWR_RD0524_01_f_2017_230				
Comment Code					
Inspector Comment					
<p>Levee Evaluation Comments</p> <p>Description: Slope protection repairs are needed along the waterside slope due to erosion and riprap displacement from high water. Based upon levee inspections, it was determined the waterside levee slope is eroding, deteriorating, and degrading. The eroded levee sections need to be restored back to design standards to prevent further deterioration and damage.</p> <p>Site ID No: 528</p> <p>Site Designation: LMA-434</p> <p>Repair Type: Erosion</p> <p>Rating: Area of Concern</p> <p>Field Date: 8/10/2017</p> <p>Notes: combined with LMA-433</p>

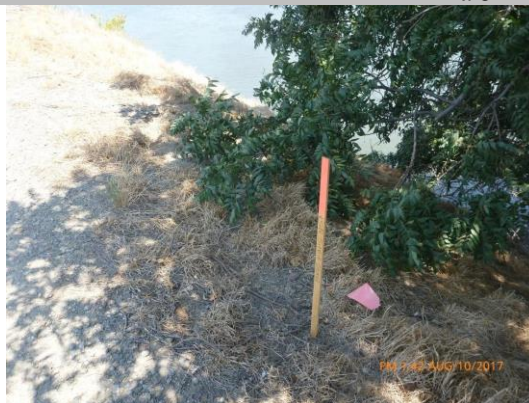
Photo 2 of 3 : LEVAL_SP_2019_528_4197.jpg

LM Start	3.26	Rating **	A/W	Issue No.	230 (cont)
LM End	3.26	Issue Type +	Ma	Location *	
Category	Supplemental			GPS Latitude/Longitude	
				Start	End
Item	2017 Storm Damage			37.908800 °	37.908700 °
				-121.325400 °	-121.325300 °
DWR ID	DWR_RD0524_01_f_2017_230				
Comment Code					
Inspector Comment					
Levee Evaluation Comments					
Description:Slope protection repairs are needed along the waterside slope due to erosion and riprap displacement from high water. Based upon levee inspections, it was determined the waterside levee slope is eroding, deteriorating, and degrading. The eroded levee sections need to be restored back to design standards to prevent further deterioration and damage.					
Site ID No:528					
Site Designation:LMA-434					
Repair Type: Erosion					
Rating:Area of Concern					
Field Date:8/10/2017					
Notes: combined with LMA-433

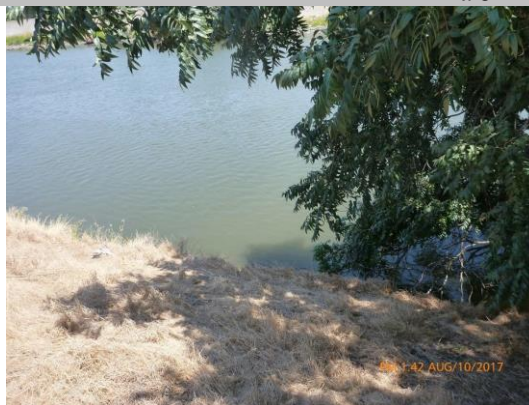
Photo 3 of 3 : LEVAL_SP_2019_528_4198.jpg

LM Start	3.26	Rating **	A/W	Issue No.	230 (cont)
LM End	3.26	Issue Type +	Ma	Location *

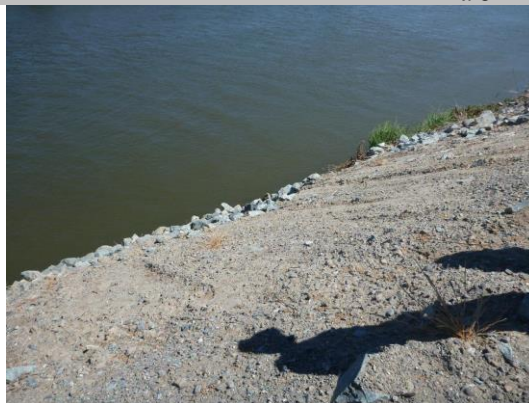
Photo 1 of 3 : LEVAL_SP_2019_467_2223.jpg

LM Start	3.30	Rating **	A/W	Issue No.	232
LM End		Issue Type +	Ma	Location *	
Category	Supplemental			GPS Latitude/Longitude	
				Start	End
Item	2017 Storm Damage			37.908200 °	°
				-121.325300 °	°
DWR ID	DWR_RD0524_01_f_2017_232

Comment Code					
Inspector Comment					
Levee Evaluation Comments					
Description:Slope protection repairs are needed along the waterside slope due to erosion. Based upon levee inspections, it was determined the waterside levee slopes were eroding, deteriorating and degrading in concave pocket sections at various locations along this levee reach. The eroded levee sections need to be restored back to design standards to prevent further deterioration of the damaged levee sections.					
Site ID No:467					
Site Designation:LMA-294					
Repair Type: Erosion					
Rating:Area of Concern					
Field Date:7/26/2017					
Notes: It looks like new rip rap was played on the lower 1/4 of the slope. There is a 2-3 ft scarp above the rip rap.

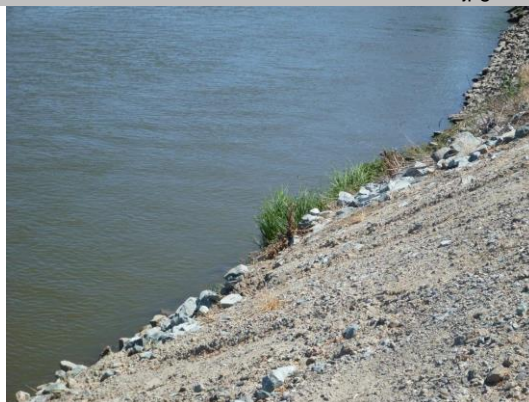
Photo 2 of 3 : LEVAL_SP_2019_467_2224.jpg

LM Start	3.30	Rating **	A/W	Issue No.	232 (cont)
LM End		Issue Type +	Ma	Location *

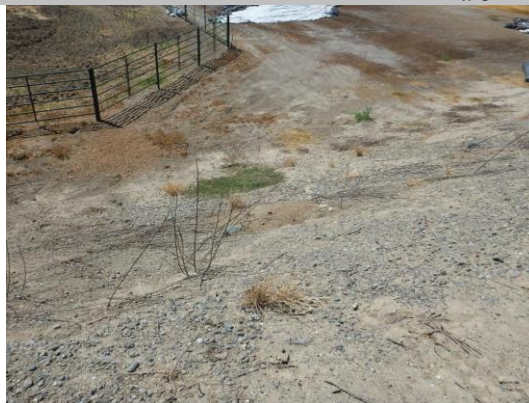
Photo 3 of 3 : LEVAL_SP_2019_467_2225.jpg

LM Start	3.30	Rating **	A/W	Issue No.	232 (cont)	
LM End		Issue Type +	Ma	Location *		
Category	Supplemental			GPS Latitude/Longitude		
				Start		End
Item	2017 Storm Damage			37.908200 °		°
				-121.325300 °		°
DWR ID	DWR_RD0524_01_f_2017_232

Comment Code						
Inspector Comment						
Levee Evaluation Comments						
Description:Slope protection repairs are needed along the waterside slope due to erosion. Based upon levee inspections, it was determined the waterside levee slopes were eroding, deteriorating and degrading in concave pocket sections at various locations along this levee reach. The eroded levee sections need to be restored back to design standards to prevent further deterioration of the damaged levee sections.						
Site ID No:467						
Site Designation:LMA-294						
Repair Type: Erosion						
Rating:Area of Concern						
Field Date:7/26/2017						
Notes: It looks like new rip rap was played on the lower 1/4 of the slope. There is a 2-3 ft scarp above the rip rap.

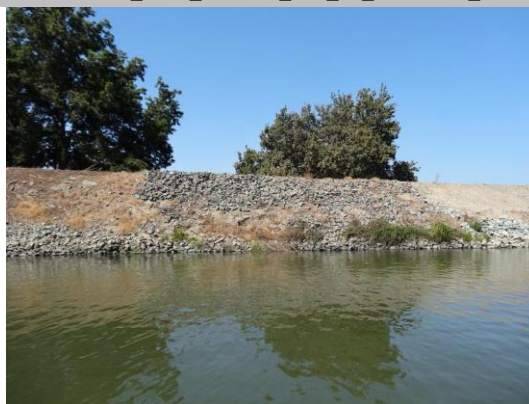
Photo 1 of 4 : SP_2019_RD0524_107_79_20190313_00108.jpg

LM Start	3.30	Rating **	A/W	Issue No.	79
LM End	3.32	Issue Type +	Ma	Location *	WS
Category	Supplemental			GPS Latitude/Longitude	
				Start	End
Item	DWR Erosion Survey			37.908090 °	37.908090 °
				-121.325090 °	-121.325090 °
DWR ID	RD0524U01RM43.86				
Comment Code					
Inspector Comment					
09/13/2017: No significant change observed.					
07/25/2016: No significant change observed.					
06/24/2015: No significant change observed.					
06/19/2014: No significant change observed.					
08/13/2013: The levee toe seems to have been protected by river rocks and vegetation on site. [2017 Site ID:RD0524U01RM43.86]

Front View of the erosion.

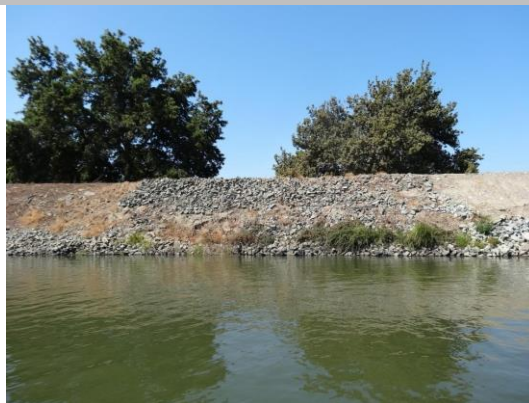
Photo 2 of 4 : SP_2019_RD0524_107_79_20190313_00109.jpg

LM Start	3.30	Rating **	A/W	Issue No.	79 (cont)
LM End	3.32	Issue Type +	Ma	Location *	WS

Front view of the erosion.

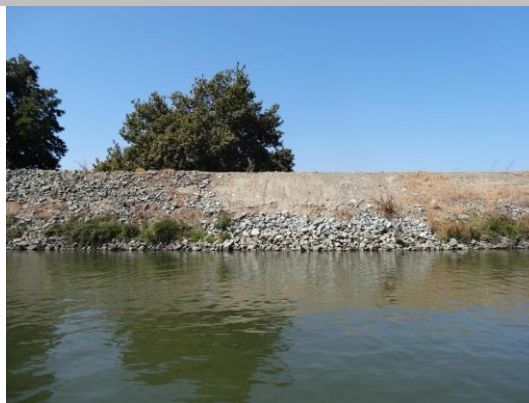
Photo 3 of 4 : SP_2019_RD0524_107_79_20190313_00110.jpg

Close view of the erosion. Note the river rocks and vegetation at the levee toe.

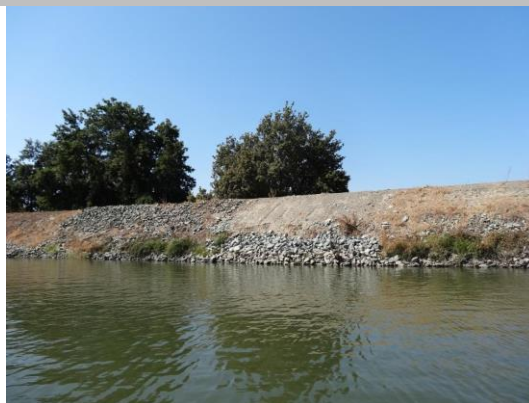
Photo 4 of 4 : SP_2019_RD0524_107_79_20190313_00111.jpg

LM Start	3.30	Rating **	A/W	Issue No.	79 (cont)
LM End	3.32	Issue Type +	Ma	Location *	WS

Front View of the erosion.

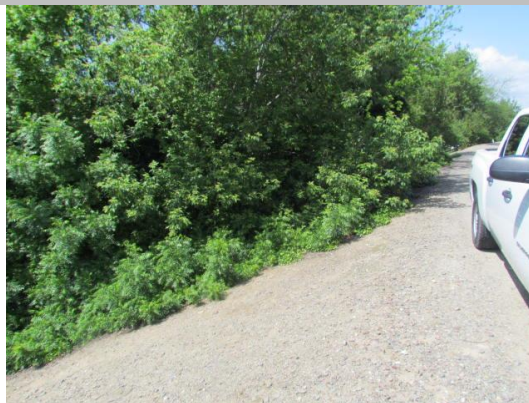
Photo 1 of 2 : SP_2019_RD0524_107_926_20190313_00292.jpg

LM Start	3.30	Rating **	M	Issue No.	926
LM End	3.37	Issue Type +	Ma	Location *	LS
Category	Earthen Levee			GPS Latitude/Longitude	
				Start	End
Item	Trim / Thin Trees			37.908158 °	37.907112 °
				-121.325418 °	-121.325350 °
DWR ID	DWR_RD0524_01_s_2012_926				
Comment Code					
T1 : Trim trees to at least five feet above ground level.					
Inspector Comment

Looking southwest at dense veg on landward slope.

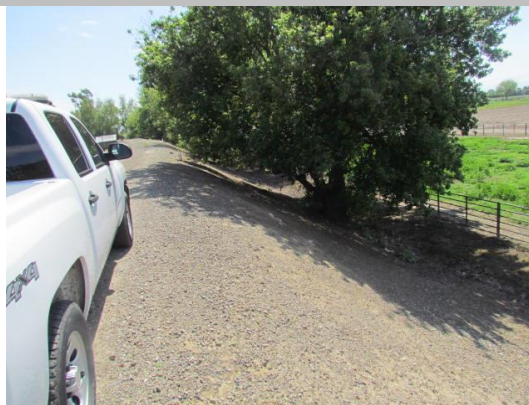
Photo 2 of 2 : SP_2019_RD0524_107_926_20190313_00293.jpg

LM Start	3.30	Rating **	M	Issue No.	926 (cont)
LM End	3.37	Issue Type +	Ma	Location *	LS

Looking at untrimmed trees on landward slope and toe.

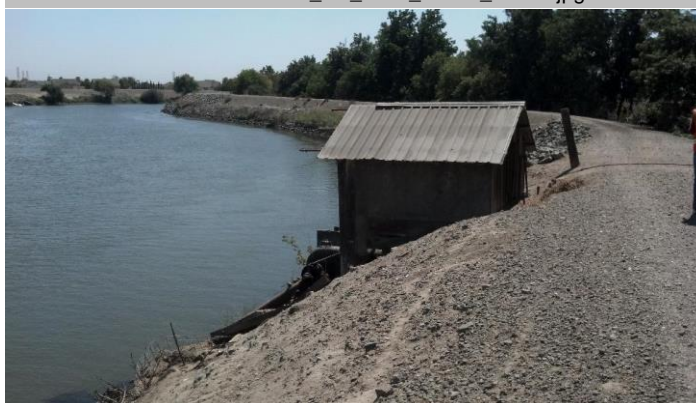
Photo 1 of 3 : UCIP_SP_2019_53357_30206.jpg

Comment Code						
Inspector Comment						
FS_ID:53357						
DS_ID:20618						
EP_NO: N/A						
Repair Type: Urgent						
Crossing Status: Found						
UCIP Comments: 10/2/2018 Same as previous inspection with severe LS slope integrity issues (D. Sanoski - DWR UCIP).11/16/2016 same as previous inspection erosion is still present on LS toe and slope. Owner will need to coordinate with CVFPB to address erosion issue on LS toe. (O. Magana - DWR UCIP)08/20/2013 Extensive erosion on LS toe at distribution box due to failure of box/pipe connection. Erosion on LS slope do to recently repaired leak at gate valve. (W. Wylie - DWR UCIP)						
FIELD_STRUCT_DESC: 14-inch steel irrigation pipe through the levee, 7 feet below the crown. Pump house located on the waterside (WS) slope. Gate valve located on the landside (LS) slope. 4-foot by 4-foot brick distribution box, built in 1918, located on the LS toe. This site was used to manufacture brick back in 1918, and some of the appurtenances that remain are still in use (distribution box and ditch). [Additional Reference(s): DWR Levee Log, 2004. USACE San Joaquin O&M Manual 7, April 1964, (HLM 3.38) 12-inch pipe listed, (conversation with owner, 2016)].

LM Start	3.35	Rating **	U	Issue No.	952 (cont)
LM End	3.35	Issue Type +	En	Location *

Pipe and pumphouse on WS slope.

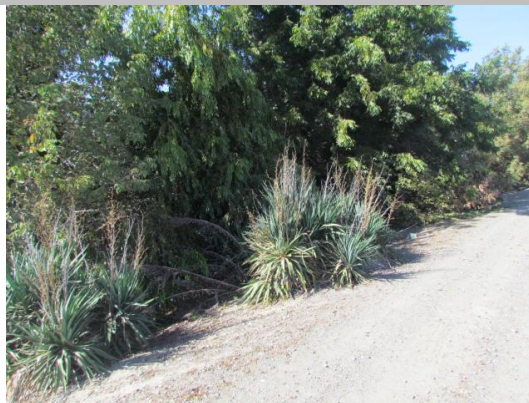
Photo 1 of 1 : SP_2019_RD0524_107_54_20190313_00074.jpg

LM Start	3.44	Rating **	U	Issue No.	54
LM End	3.47	Issue Type +	Ma	Location *	LS
Category	Earthen Levee			GPS Latitude/Longitude	
				Start	End
Item	Trim / Thin Trees			37.906291 °	37.906018 °
				-121.324748 °	-121.324300 °
DWR ID	DWR_RD0524_01_s_2012_54				
Comment Code					
T3 : Trim and thin trees to allow visibility of the ground and room to flood fight.					
Inspector Comment					
Dense untrimmed trees on landside slope.

Looking northwest at dense vegetation on landside slope.

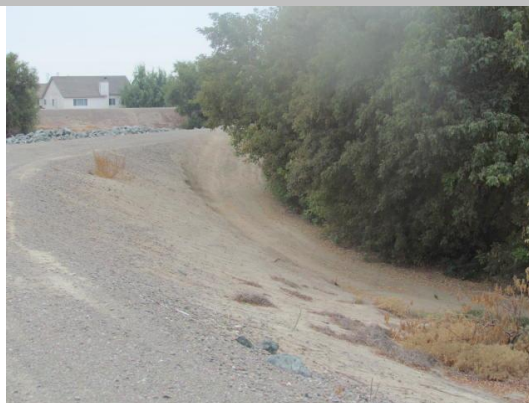
Photo 1 of 1 : SP_2019_RD0524_107_265_20190313_00279.jpg

LM Start	3.51	Rating **	M	Issue No.	265
LM End	3.51	Issue Type +	En	Location *	LS
Category	Earthen Levee			GPS Latitude/Longitude	
				Start	End
Item	Encroachments			37.905552 °	37.905552 °
				-121.323847 °	-121.323847 °
DWR ID	DWR_RD0524_01_s_2012_265				
Comment Code					
RA : Ramp					
Inspector Comment					
Unauthorized ramp on landside slope.

Looking southeast at unauthorized ramp on landside slope and toe.

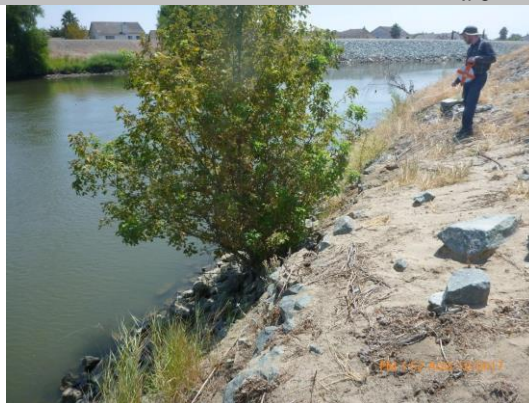
Photo 1 of 3 : LEVAL_SP_2019_526_4201.jpg

LM Start	3.53	Rating **	A/W	Issue No.	233
LM End	3.54	Issue Type +	Ma	Location *	
Category	Supplemental			GPS Latitude/Longitude	
				Start	End
Item	2017 Storm Damage			37.905300 °	37.905200 °
				-121.323800 °	-121.323900 °
DWR ID	DWR_RD0524_01_f_2017_233				
Comment Code					
Inspector Comment					
Levee Evaluation Comments					
Description:Slope protection repairs are needed along the waterside slope due to erosion and riprap displacement from high water. Based upon levee inspections, it was determined the waterside levee slope is eroding, deteriorating, and degrading. The eroded levee sections need to be restored back to design standards to prevent further deterioration and damage.					
Site ID No:526					
Site Designation:LMA-432					
Repair Type: Erosion					
Rating:Area of Concern					
Field Date:8/10/2017					
Notes:

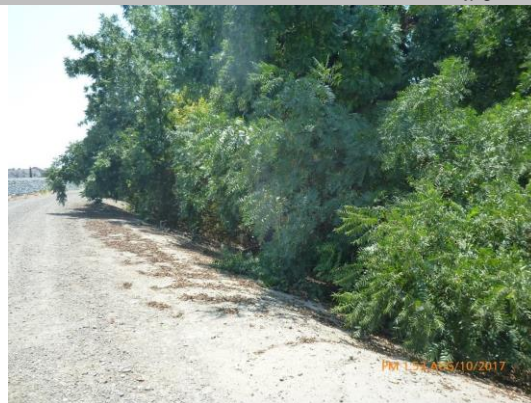
Photo 3 of 3 : LEVAL_SP_2019_526_4203.jpg

LM Start	3.53	Rating **	A/W	Issue No.	233 (cont)	
LM End	3.54	Issue Type +	Ma	Location *		
Category	Supplemental			GPS Latitude/Longitude		
				Start	End	
Item	2017 Storm Damage			37.905300 °	37.905200 °	
				-121.323800 °	-121.323900 °	
DWR ID	DWR_RD0524_01_f_2017_233					
Comment Code						
Inspector Comment						
Levee Evaluation Comments						
Description:Slope protection repairs are needed along the waterside slope due to erosion and riprap displacement from high water. Based upon levee inspections, it was determined the waterside levee slope is eroding, deteriorating, and degrading. The eroded levee sections need to be restored back to design standards to prevent further deterioration and damage.						
Site ID No:526						
Site Designation:LMA-432						
Repair Type: Erosion						
Rating:Area of Concern						
Field Date:8/10/2017						
Notes:
